## 1994 44' Moody

# Pre-Purchase Report of Marine Survey

**Date Of Survey:** 5 Dec 2024 and 27 Dec 2024

**Report Submitted On:** 28 December 2024

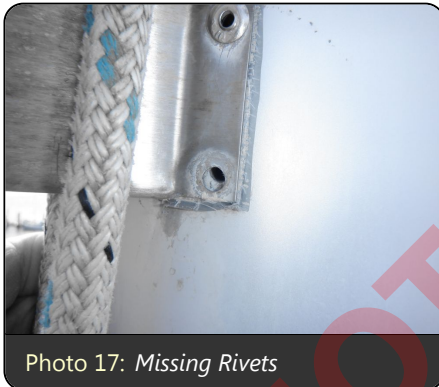
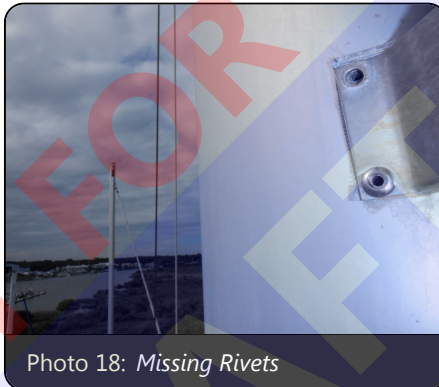
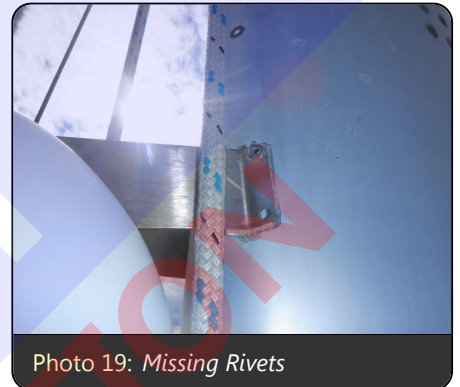
Radar Reflector mounting bracket is missing several rivets for attachment.

Photo 17: Missing Rivets

Photo 18: Missing Rivets

Photo 19: Missing Rivets

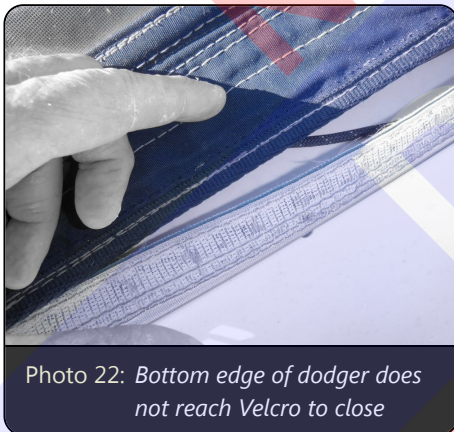
Photo 22: Bottom edge of dodger does not reach Velcro to close

Note: The front lower edge of the Dodger canvas has shrunk and does not meet the velcro enclosure strip, recommend to have a piece fabricated to extend the lower end of Dodger to maintain water intrusion.

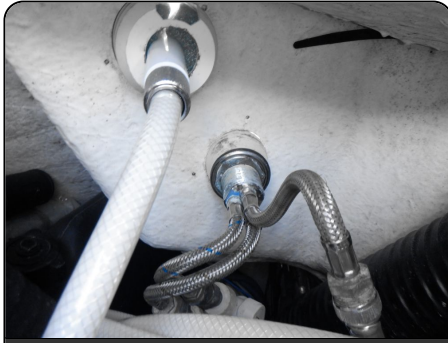
Note: The aft shower Appear to have new water lines, although the valve is very corroded during time of survey.

Photo 23: Aft deck shower water lines

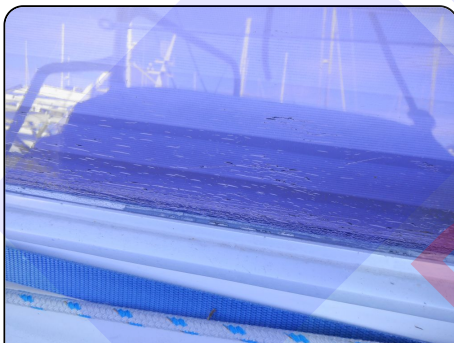
The vessel's windows were well fit with some glazing from the sun was observed.

Photo 25: Port and starboard windows have glazing from the sun

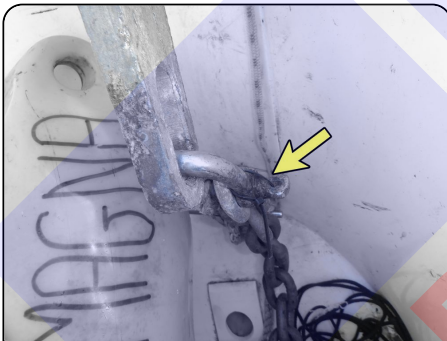
Photo 28: No safety wire just a zip tie

1. Recommend confirming that the anchor's shackle bolts are properly secured with safety wire (seizing wire) to prevent accidental anchor loss, as necessary.
2. 1 x Secondary Anchor, and 1x Fortress FX23.

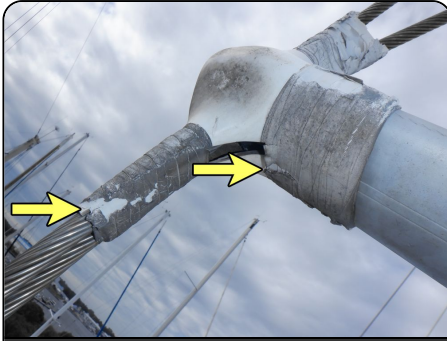
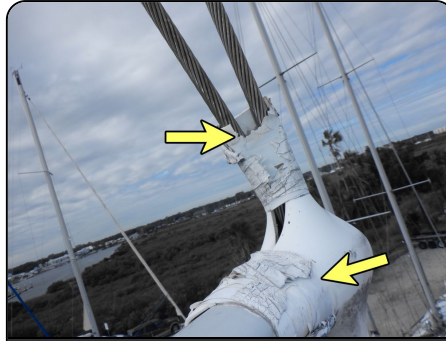
Note: The rigging tape on the spreader boots is sun damaged and need to be retaped.

Photo 38: Rigging tape is sun damaged and starting to rip.

Photo 39: Rigging tape is sun damaged and starting to rip.

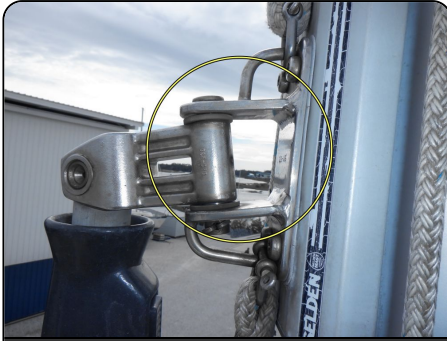
Note: The traveler for the mast pole lift is bent and should be watched and replaced if starts to crack. (See Photo), also the screws at the top of the track are backing out and should be retightened. (see Photo).

Photo 42: Bent traveler Car

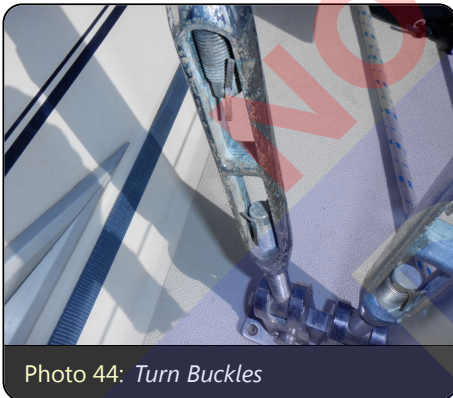
Some significant corrosion had developed on a few of the open design turnbuckles. Recommend further investigation and the periodic exercise/adjustment of the turnbuckles.

Photo 44: Turn Buckles

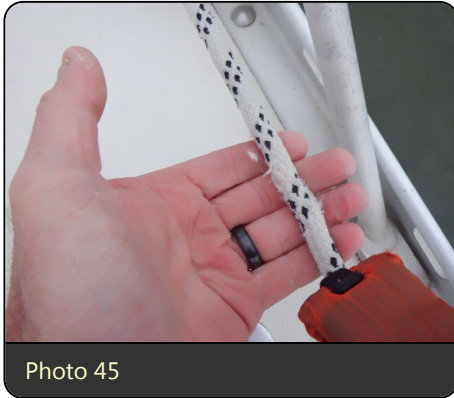
Note: The staysail retrieval roller furling line is frayed and possibly has broken core line. (See Photo)

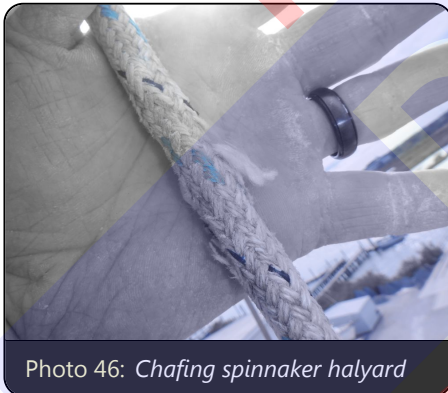
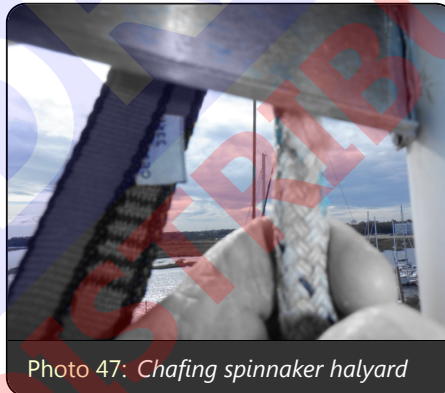
**It was reported by the current owner that the halyard had broke in the past due to rubbing on the bracket.**

**Recommend to somehow prevent chafing when new halyard is installed.**

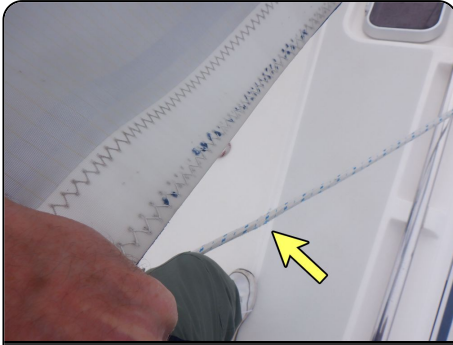
1. The headsail sheet lines appear to be starting to chafe and possibly have broken core lines within the center part of the line. (Noticed on port side)

Photo 48: Port side Headsail Sheet line frayed and inner core lines possibly broken

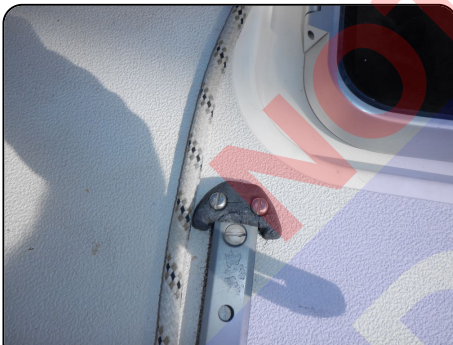
Note: A few of the car stops need to be replaced. (See Photo)

Photo 49: Stops are weathered and need to be replaced

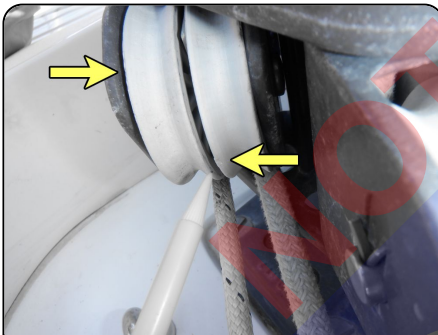
Some of the shives at the bottom of the mast are becoming damaged by the sun and edges are starting to chip which can cause chafing to running rigging, recommend to keep watch and replace as needed.

Swivel block on top of boom is chipped and should be replaced to prevent chafing line. (See Photo)

Photo 51: Chips in the edge of shives

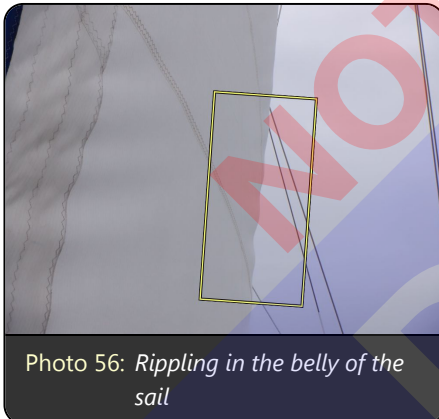
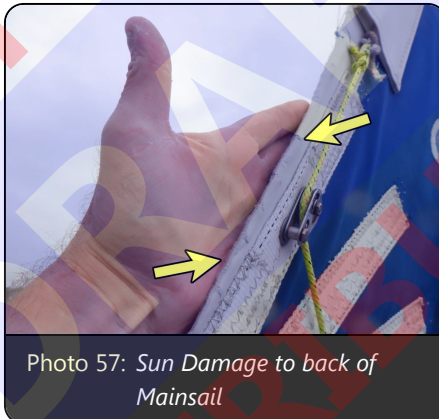
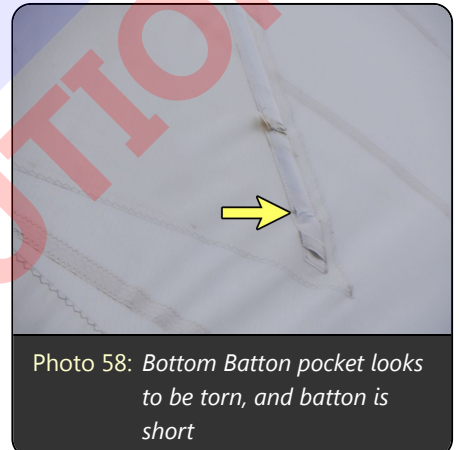
1. Rippling in the belly of the sail is an indicator that the sail has been used extensively and the sail fabric has stretched, the sail is still servicable but will be needing to be replaced soon depending on the amount of use.
2. Bottom Batton looks too short and the bottom batton pocket looks to be torn.
3. The back edge of the Mainsail has sun damage.

Photo 56: Rippling in the belly of the sail

Photo 57: Sun Damage to back of Mainsail

Photo 58: Bottom Batton pocket looks to be torn, and batton is short

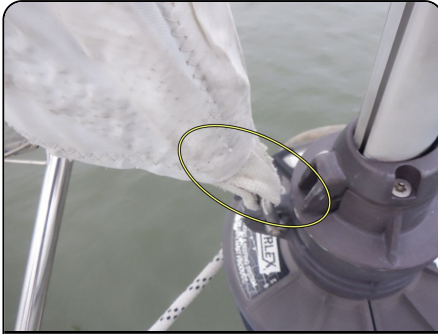
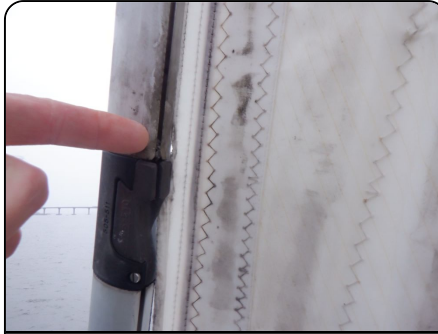
1. Areas of the stitching on the Sacrificial Canvas has started to come undone and should be restitched.

Photo 59: Headsail : Some Chafing and wear on the webbing at roller attachment point

Photo 60: Headsail: Small rip in sail material at bottom of the track slide

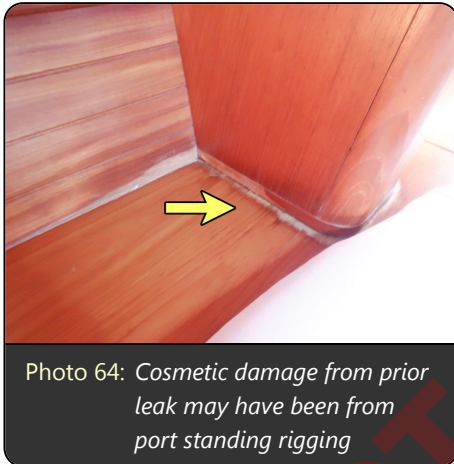
Note: On port side some cosmetic water damage from past leak was observed. (See Photo)

Photo 64: Cosmetic damage from prior leak may have been from port standing rigging

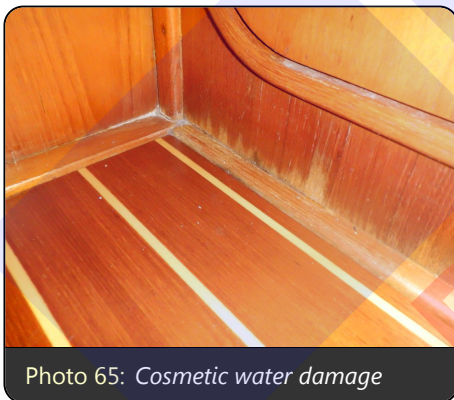
Note: Cosmetic damage to bulkhead due to the shower pan overflow noted at floor of the V-berth/common head. See Photo)

Photo 65: Cosmetic water damage

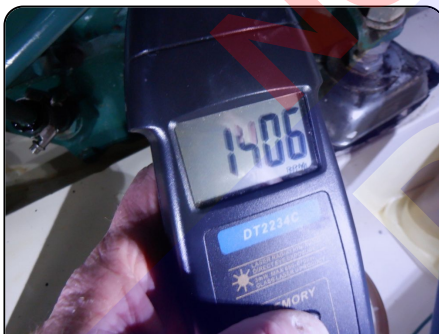
**NOTE: With the difference of the Vessels Tachometer to the actual RPMs the engine is putting out, it should be taken in to consideration to run at a MAX RPMs of approximately 2320 to 2465 RPMs MAXIMUM using the helms tachometer for longer periods of time. This is up to the owner although a recommendation and a cruising speed currents, sea conditions, and wind will also become a factor.**

Photo 71: 1406 RPM's when  
Tachometer showed 1500  
RPM's

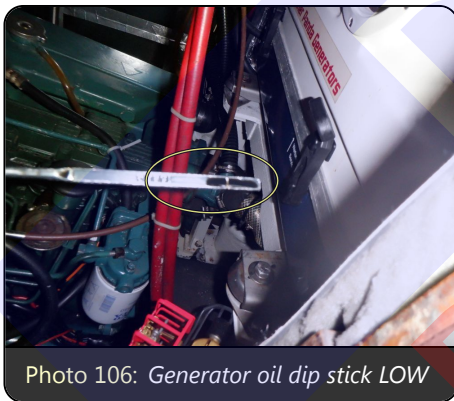
Oil levels were **low** on the generator's oil sump dipsticks.

Photo 106: Generator oil dip stick LOW

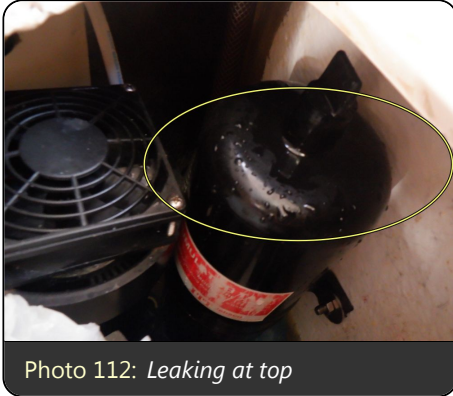
Photo 112: *Leaking at top*

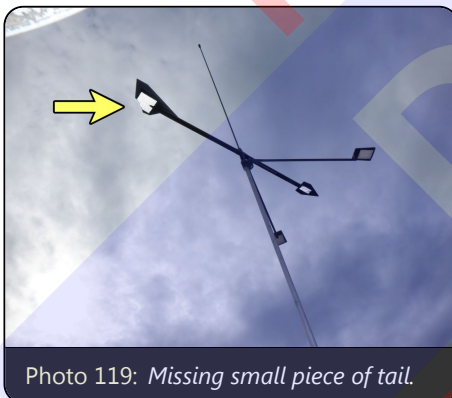
The Windex was still operational although it had a small piece missing out of the tail. (See Photo)  
Does not seem to hinder the Windex.

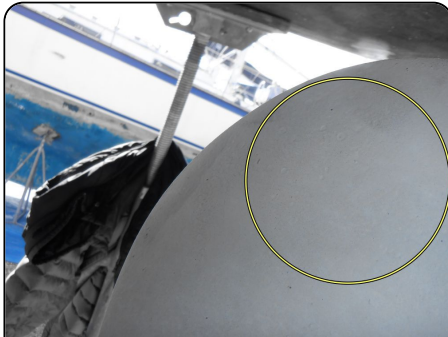
Photo 120: Pits in the propeller

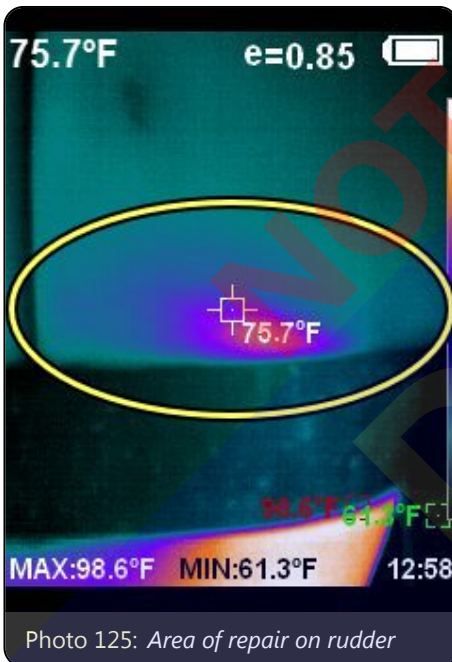
Note Thermal Imagery indicated a small repair was made on the starboard side of the rudder just above the pental strap. (See Photo)

Photo 125: Area of repair on rudder

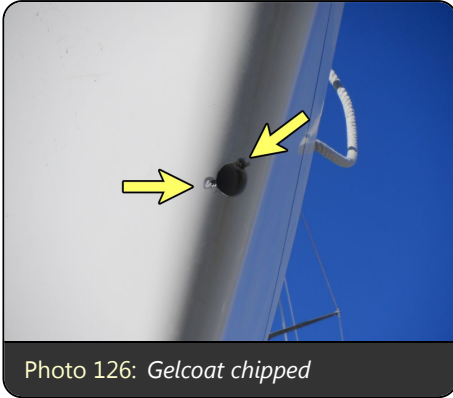
Note: Drain hole center of bow has slight gelcoat chips which is cosmetic. (see Photo)

Photo 126: Gelcoat chipped

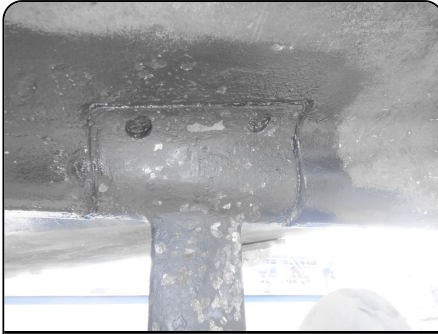
The antifouling bottom paint appeared to be at the end of its serviceable life, was worn thin or flaked off in several areas and some areas of previously flaked off bottom paint were painted over.

Photo 130: Paint peeling in areas and was recoated with ablative bottom paint.

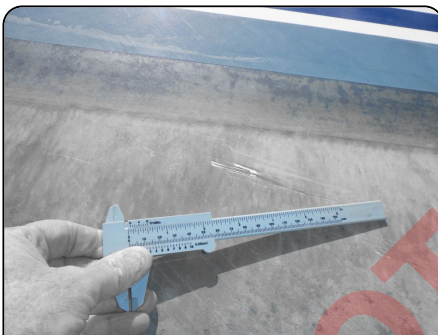
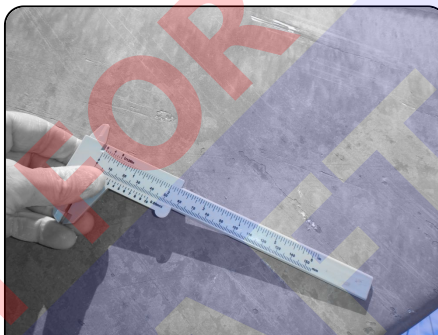
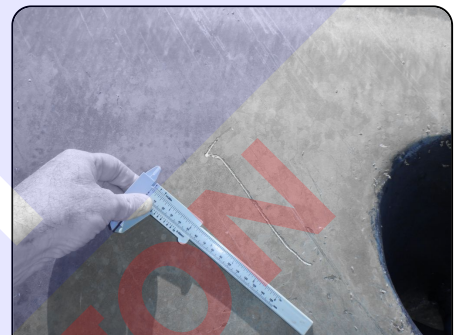
Photo 133: Deep scrapes in bottom paint possibly caused while retrieving anchor

Photo 134: Deep scrapes in bottom paint possibly caused while retrieving anchor

Photo 135: Deep scrapes in bottom paint possibly caused while retrieving anchor

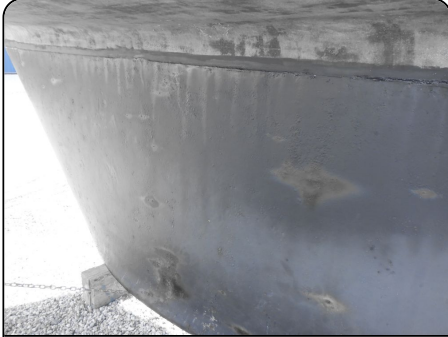
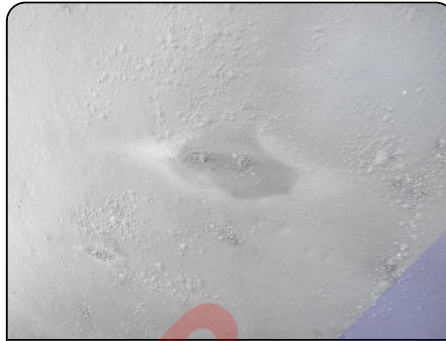
Photo 136: Keel exposed and rusting

Photo 137: Keel *exposed* and rusting  
Bottom *paint* peeling

The keel has areas that the bottom paint is gone and the cast iron is exposed causing rust, recommend to have keel grit blasted re-primed and coated with bottom paint.
