## 1994 44' Moody

# Pre-Purchase Report of Marine Survey

**Date Of Survey:** 5 Dec 2024 and 27 Dec 2024

**Report Submitted On:** 28 December 2024

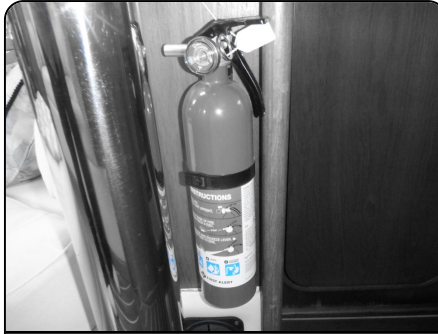
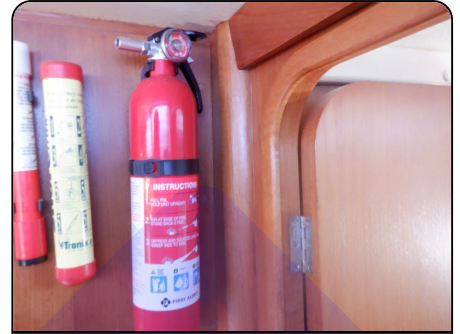
Photo 7: ABC Fire Extinguisher

Photo 8: ABC Fire Extinguisher

Photo 9: ABC Fire Extinguisher

Photo 10: ABC Fire Extinguisher

Note: Recommended that Fire extinguishers should be inspected/serviced annually by qualified service personnel and securely mounted in prominent locations.

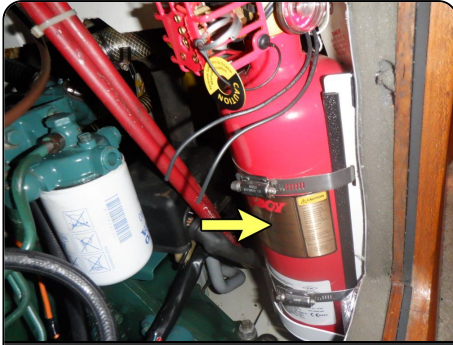
Fireboy automatic fire extinguisher clean Agent located in engine space port side of engine.

Photo 14: fireboy automatic fire extinguisher

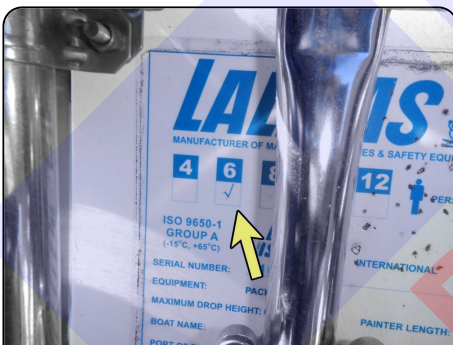
Data tags were weathered and illegible.

Note The current owner stated that it has not been re- certified several years beyond expiration date.

Photo 16: 6 person Life raft Needs Re-certified

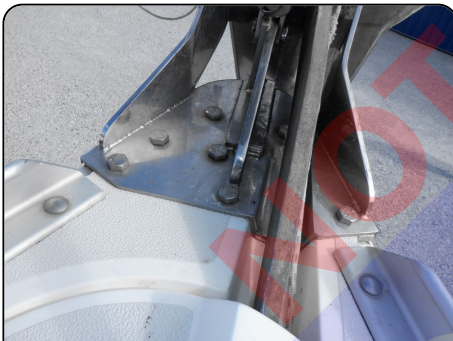
The anchor fairlead chute and its associated hardware were inspected, the rollers moved freely and all components were found to function as intended when briefly tested.

Photo 26: Anchor chute and roller

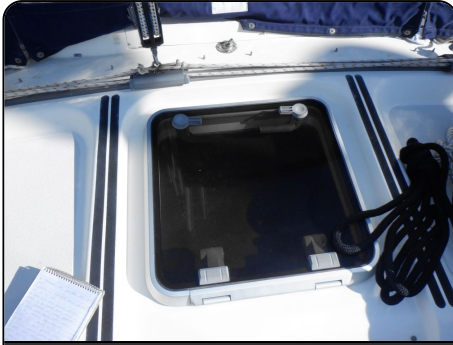
Note: All escape hatches were clear and operational at the time of survey.

Photo 27: Salon escape hatch

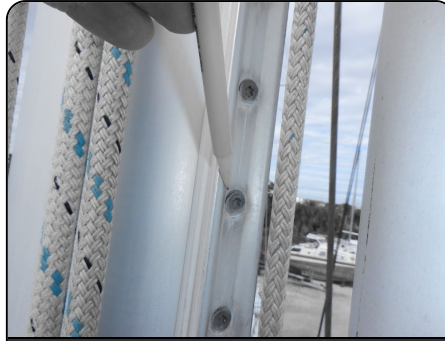
Photo 43: Screws backing out of top of track

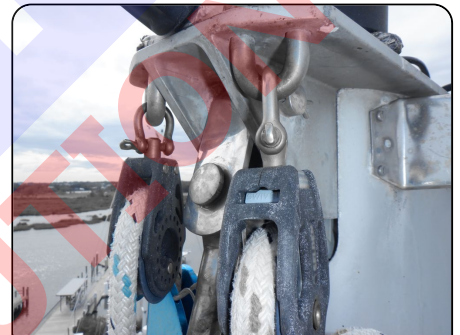
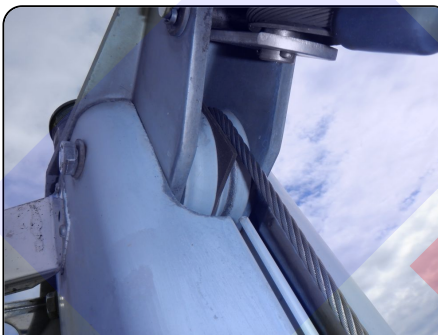
Photo 53: Shives at the top of the mast

Photo 54: Shives at the top of the mast

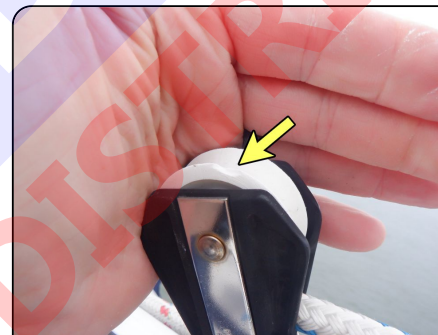
Photo 55: Swivel block on top of boom is chipped and will start to cut and chafe line

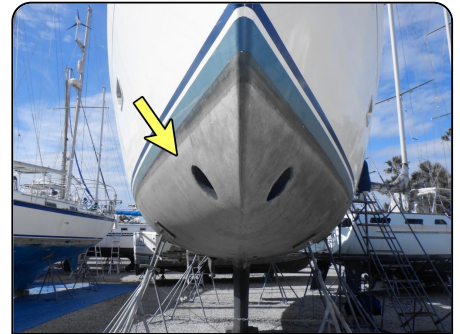
The bow thruster was demonstrated from the home controls. It was noticed that the valve thruster 2 installed in the bow of the vessel was off center in a perfectly perpendicular to the center line of the hull.

The valve thruster itself is sitting squarely in the mouth of the thruster tube as per manufacturers recommendation, this offset of the bow thruster has not hindered the performance of the valve thruster.

Photo 94: Bow thruster tube is off center line of vessel (Slightly forward on starboard side)

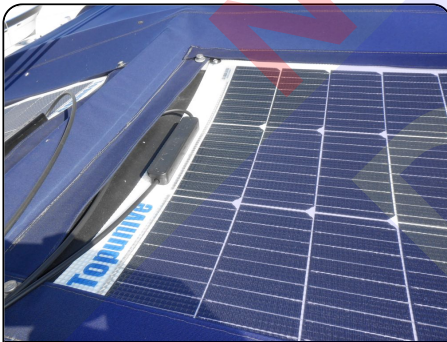
2 each Topunive Solar panels attached to the bimini top (Unknown Watts)

Photo 108: 2 each Topunive Solar panels

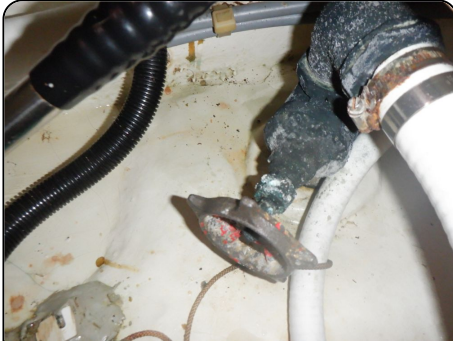
Discharge can be pumped out at deck or manually overboard, pump located under forward sole.

Photo 115: Valve for overboard discharge.

Always ensure that the blackwater waste tank's overboard discharge seacock valve remains closed, as the vessel's operator is responsible for sewage discharge in areas prohibited by law.

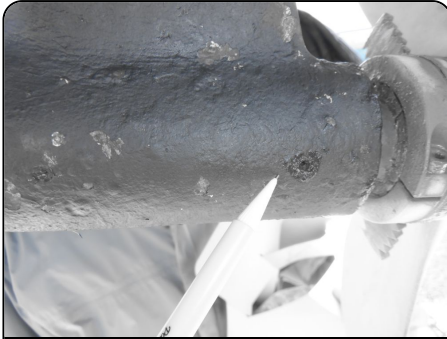
The cutless bearings showed signs of excessive wear, due for replacement during the first part of the survey.

Photo 123: Cutless Bearing set screws in place

Note: **New** Cutlass bearing replaced 8th December 2025.

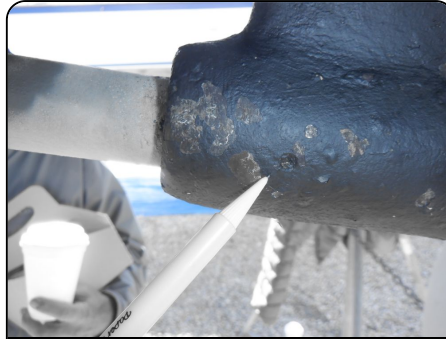
Photo 124: Cutless Bearing set screws in place

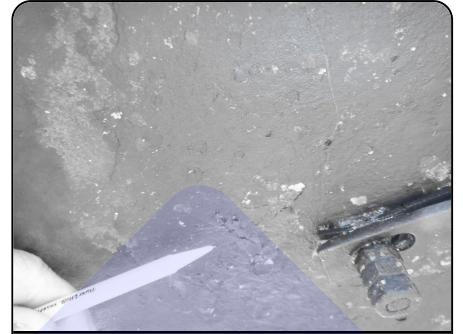
The antifouling bottom paint appeared to be at the end of its serviceable life, was worn thin or flaked off in several areas and some areas of previously flaked off bottom paint were painted over.

Photo 132: Paint peeling in areas and was recoated with ablative bottom paint.
