## 1994 44' Moody

# Pre-Purchase Report of Marine Survey

**Date Of Survey:** 5 Dec 2024 and 27 Dec 2024

**Report Submitted On:** 28 December 2024

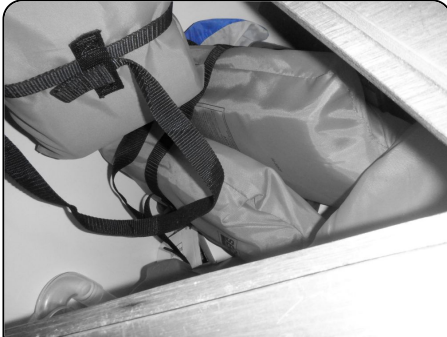
Photo 3: Type II PFD's

Note: Recommend to use Type I when sailing offshore.

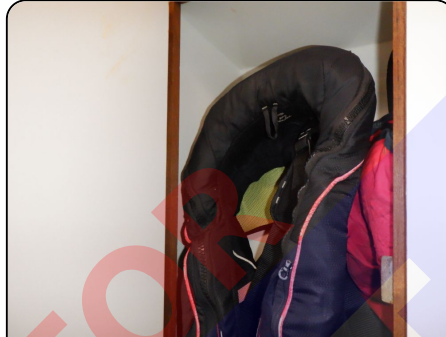
Photo 4: Type V PFD's

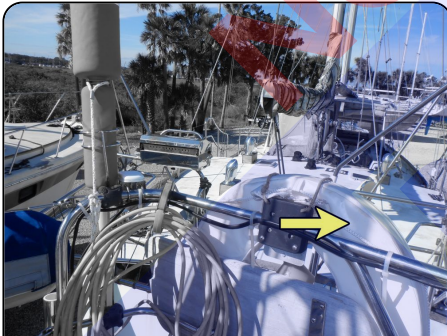
Photo 5: Horseshoe

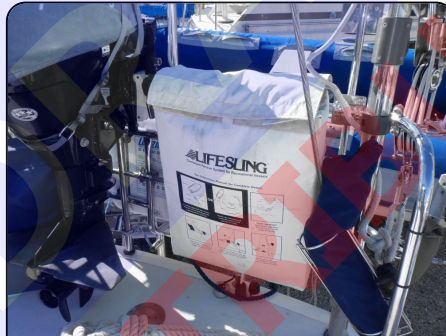
Photo 6: Life Sling

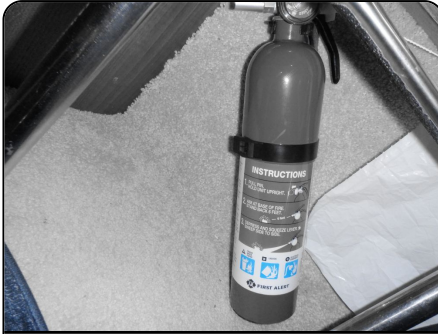
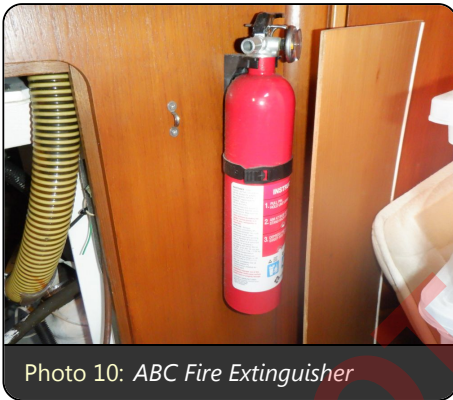
Photo 7: ABC Fire Extinguisher

Photo 8: ABC Fire Extinguisher

Photo 9: ABC Fire Extinguisher

Photo 10: ABC Fire Extinguisher

Note: Recommended that Fire extinguishers should be inspected/serviced annually by qualified service personnel and securely mounted in prominent locations.

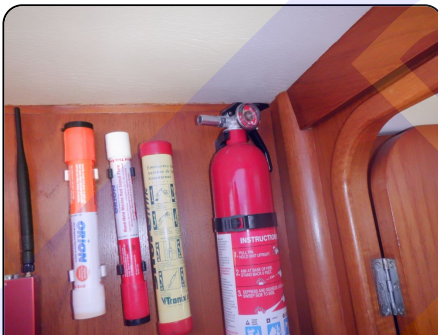
Photo 11: Signal Flares

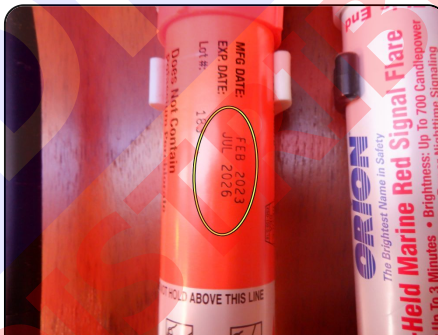
Photo 12: Expires Date July 2026

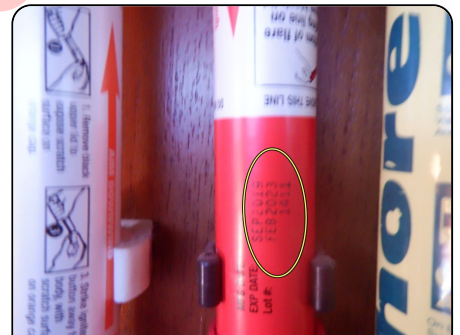
Photo 13: Date Expired Feb 2023

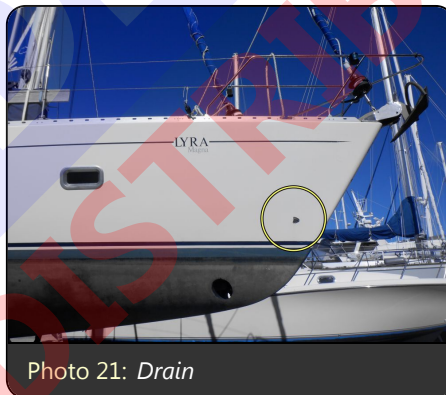
Photo 20: Drain

Photo 21: Drain

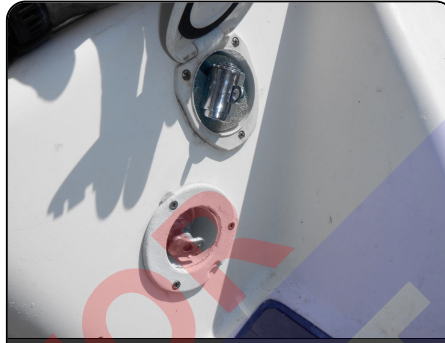
Photo 24: Aft deck shower

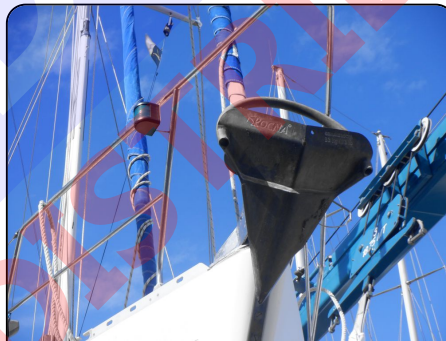
Photo 29: Rocna 73lb. Anchor

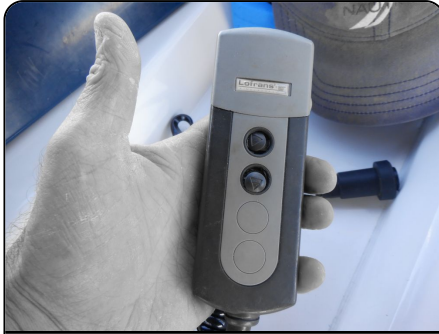
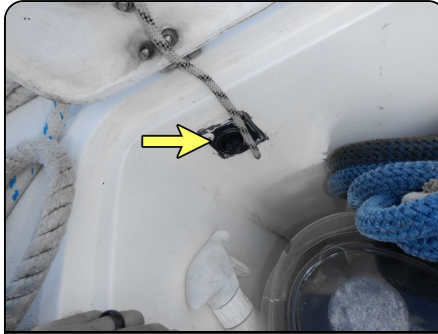
Photo 30: Hand held windless control

Photo 31: Hand held control port

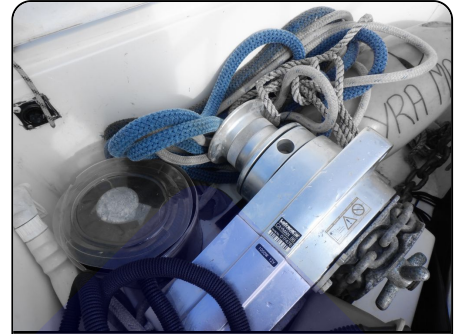
Photo 32: Windlass

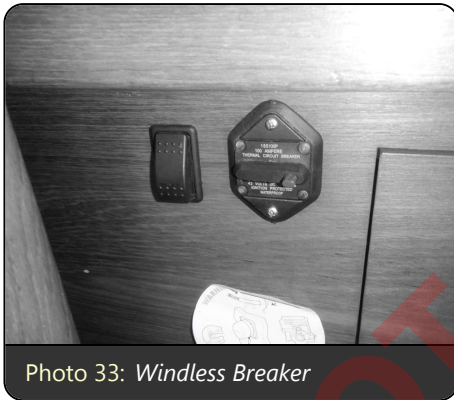
Note: The breaker for the windlass is located in the V-berth on the front side of the bunk.

Photo 33: Windless Breaker

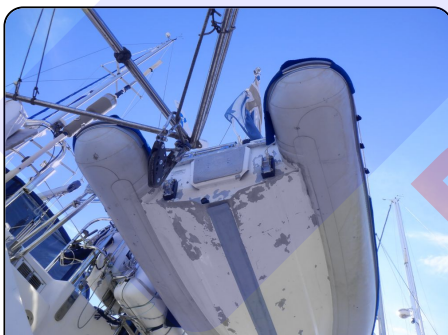
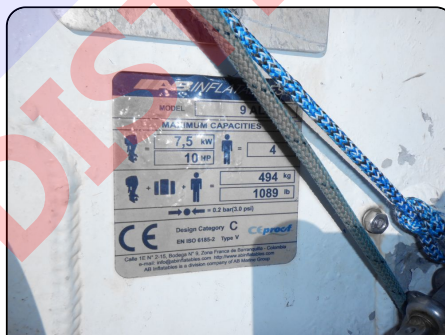
Photo 34: RIB

Photo 35: AB Inflatable

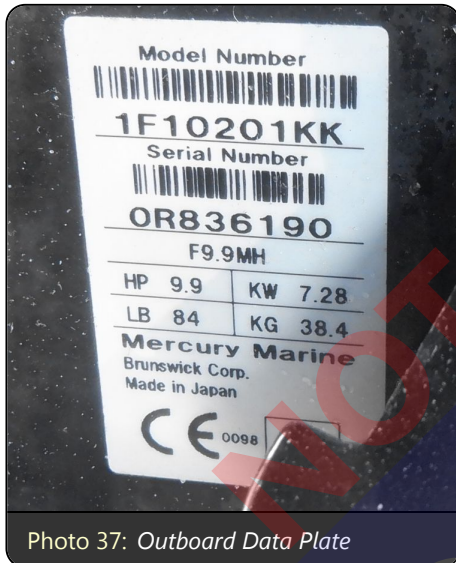
Mercury Marine 9.9HP Four Stroke outboard.

Not Demonstrated.

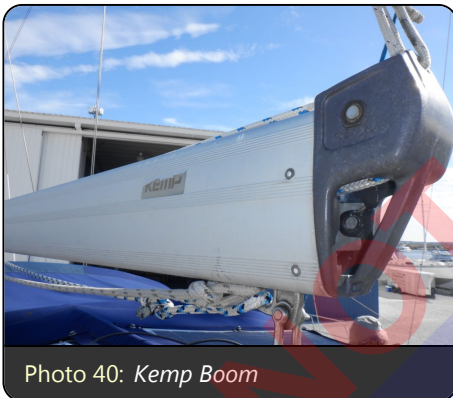
Photo 40: Kemp Boom

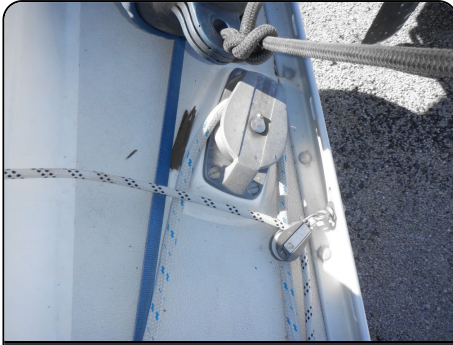
The turning blocks were securely fit (while not under load) and the sheaves moved freely when tested.

Photo 50: Turning blocks

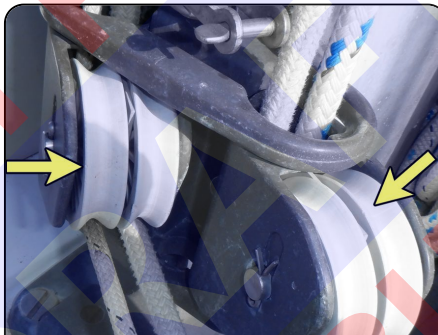
Photo 52: Chips in the edge of shives

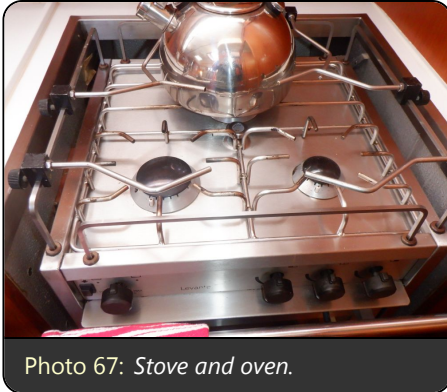
There is **NO** 12 volt solenoid on the propane tanks as recommended by ABYC for safety, recommend to install a propane solenoid for extra safety.

Photo 67: Stove and oven.

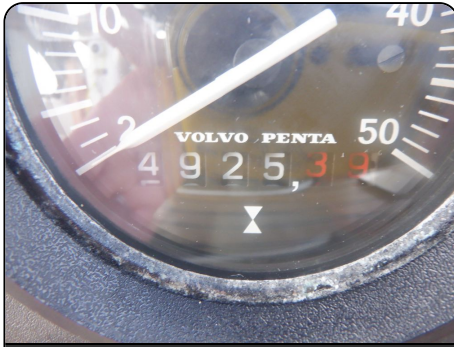
Note: The engine has had a rebuild and recent work after the rebuild. Unsure hours at rebuild.

Photo 69: Engine Hours - 4925.3

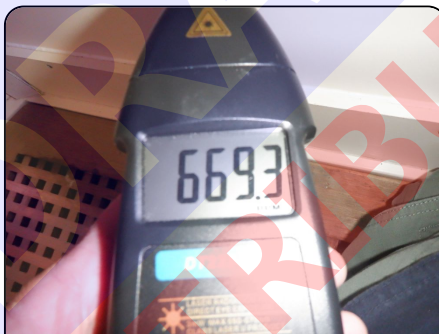
Photo 72: 669.3 RPM's when  
Tachometer showed Idel  
speed at 700 RPM's

**NOTE: With the difference of the Vessels Tachometer to the actual RPMs the engine is putting out, it should be taken in to consideration to run at a MAX RPMs of approximately 2320 to 2465 RPMs MAXIMUM using the helms tachometer for longer periods of time. This is up to the owner although a recommendation and a cruising speed currents, sea conditions, and wind will also become a factor.**

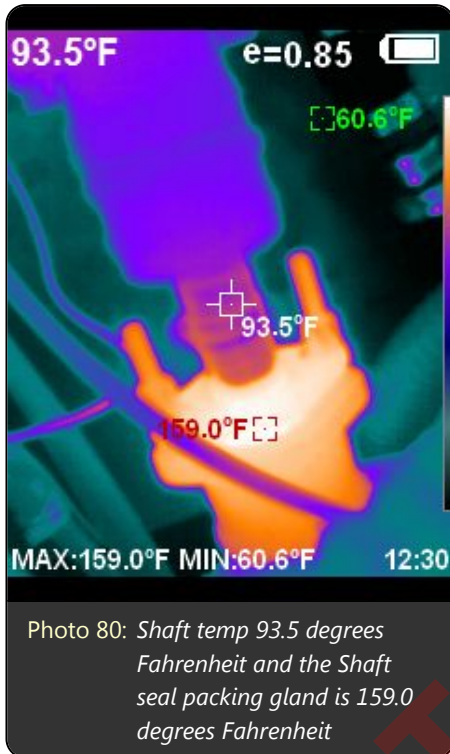
Note: At idel speed the shaft seal should drip 1 to 3 drops of water with-in every 1 minute, a packing gland seal too tight will not allow the water to keep it cool and will cause the packing gland to oveheat.

Recommend to periodically check to insure proper cooling of packing gland.

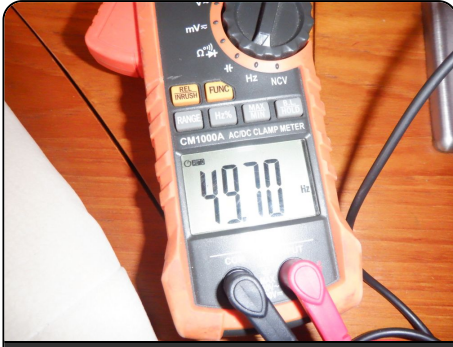
The Generator runs on 50 Hertz, it was tested and meter indicated the Generator was at 49.7 Hz. (See Photo)

Photo 96: Generator Hertz

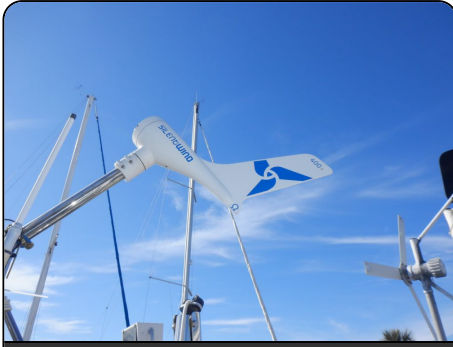
Silent wind 400 watt was disconnected for haul out and it will be reconnected and owner indicated he would install the new controller.

Photo 110: Silent wind 400 watt

Note: Recommend to ensure installation is completed before taking possession of the vessel.

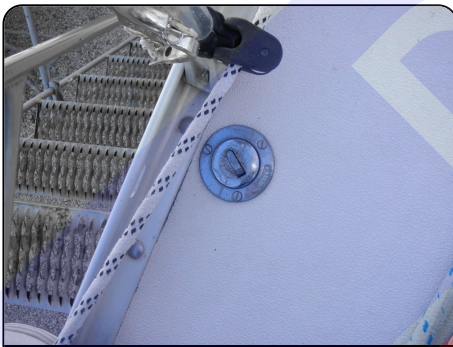
Port amidships side deck.

Photo 111: water fill

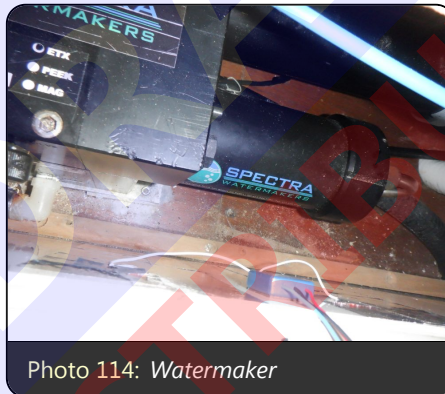
Spectra Water was not tested during the survey.

Photo 114: *Watermaker*

Note: Recommend To consult with the current owner to understand if the water maker has been pickled, and also the operation of the water maker.

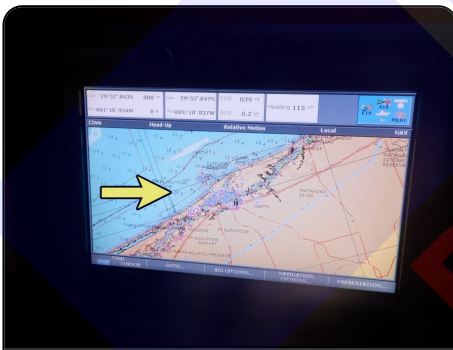
AIS target data was observed on the interfaced multi-function navigation units.

Photo 116: AIS Targets shown

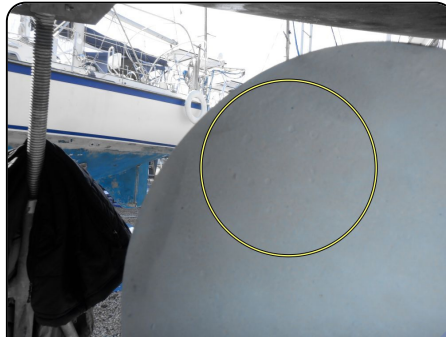
**Note: Looking close at the propeller although they have been coated with an antifouling paint they show signs of pitting. This pitting could be caused from either cathodic corrosion, or cavitation. Due to the anti-falling pin covering the propeller.**

Photo 121: Pits in the propeller

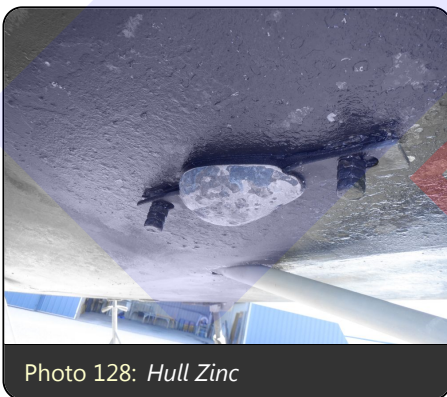
The underwater hull zinc anodes were wasting but were not yet past their 50% wastage point. Shaft zinc was new at time of survey. Monitor frequently.

Photo 128: Hull Zinc

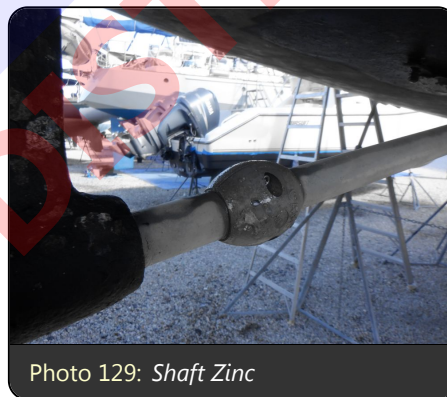
Photo 129: Shaft Zinc
